# STORM WATER DRAINAGE

TOP FIVE AREAS ACCORDING TO STREET DEPARTMENT

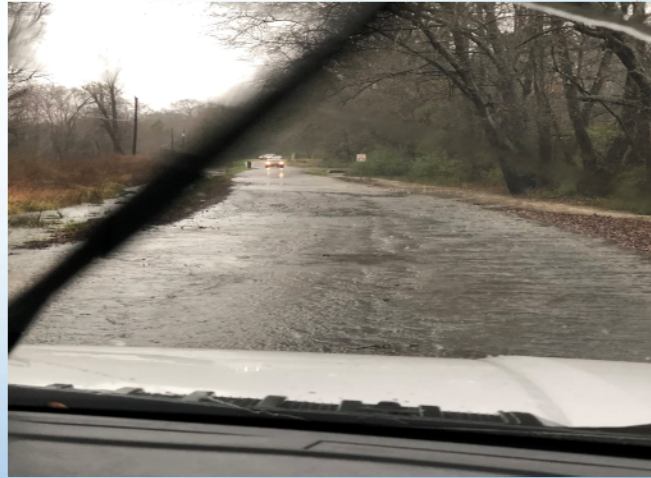
**SYCAMORE ST.**

@ UNIVERSITY STREET

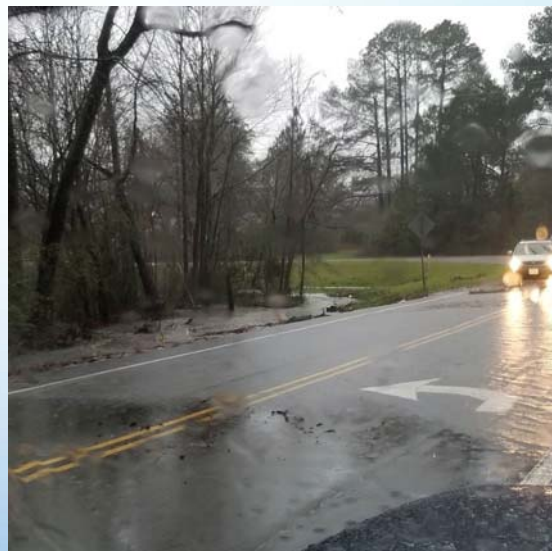
**PATTEN STREET**

@ LOOP 564

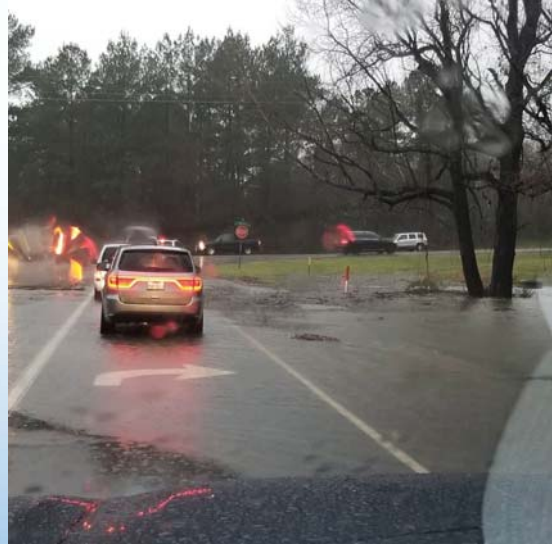
## PATTEN & LOOP 564

@ COUNTRY CLUB

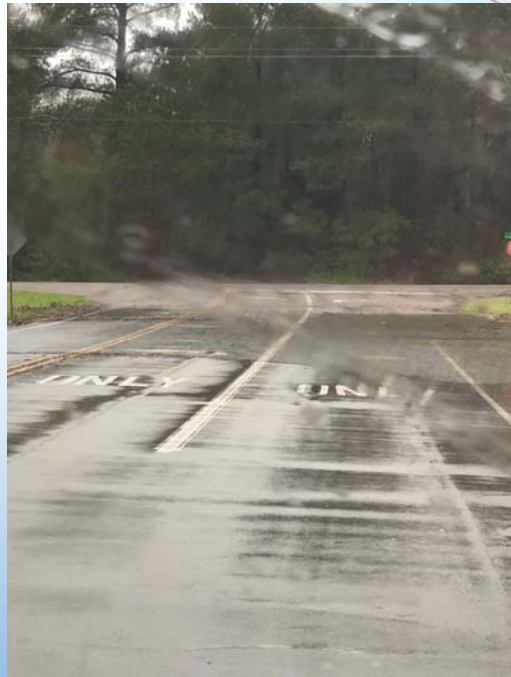
## PATTEN & LOOP

FLOODING ON PATTEN & LOOP 564.  
MAINLY DUE TO LAND CLEARING DEBRIS  
FROM MISD CLOGGING CLUVERTS

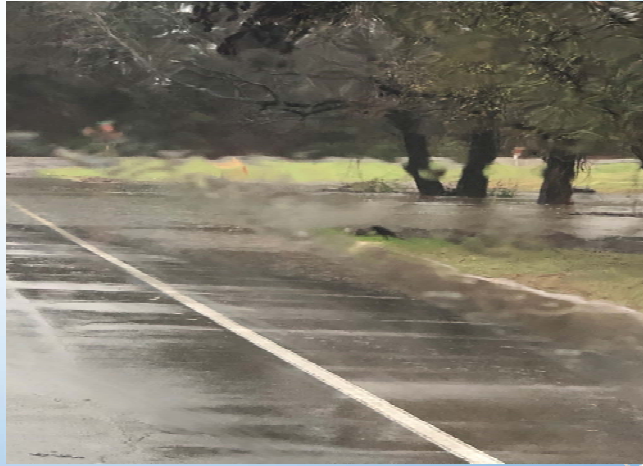
## PATTEN & LOOP 564

@ COUNTRY CLUB

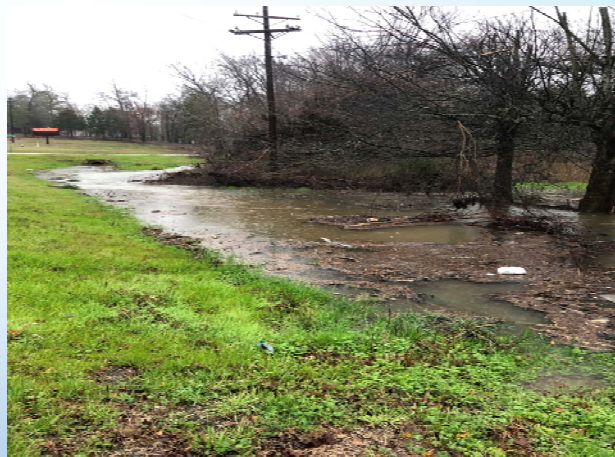
## PATTEN & LOOP 564

FLOODING IN STATE RIGHT OF WAY ON  
LOOP 564 AT OLD DRIVING RANGE.  
LOOKING NORTH TO PATTEN. NOTICE LACK  
OF WATER COMING FROM CULVERT.  
CAUSED BY DEBRIS FROM MISD.

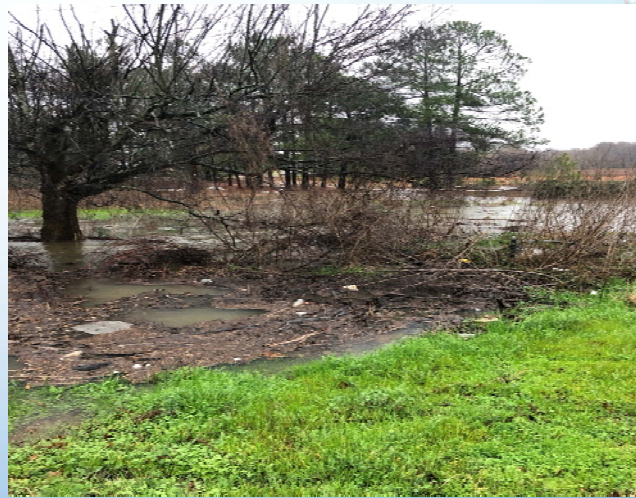
## PATTEN & LOOP 564

FLOODING IN STATE RIGHT OF WAY ON LOOP 564. LOOKING NORTH TO PATTEN AT OLD DRIVING RANGE. THERE IS A CULVERT UNDERNEATH DRIVEWAY THAT IS CLOGGED FROM MISD DEBRIS.

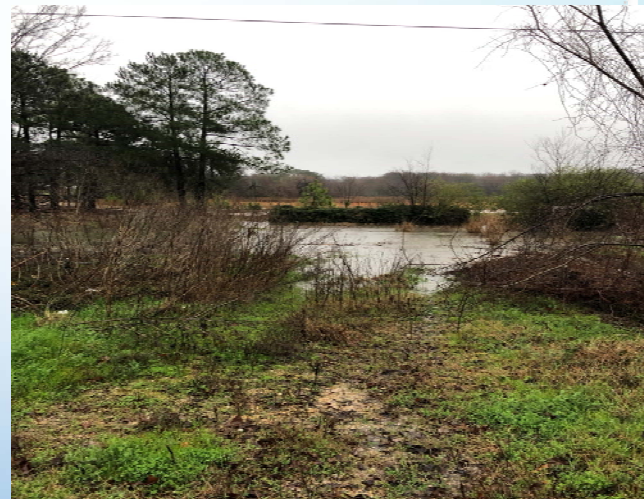
## PATTEN & LOOP 564

DRIVEWAY AT OLD DRIVING RANGE. WATER IS BEING DIVERTED AROUND DRIVE WAY DUE TO CLOGGED CULVERT.

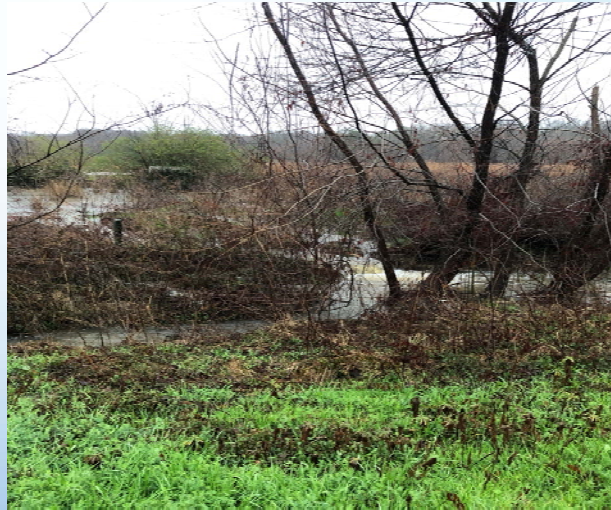
## PATTEN & LOOP 564

OLD DRIVING RANGE. JUST SOUTH OF DRIVE WAY. WATER COMING FROM LEFT IS FORM THE CLOGGED CULVERT. VERY LITTLE WATER COMING FROM CULVERT. WATER COMING FROM MIDDLE IS COMING FROM DIVERTED WATER STREAM AROUND DRIVE WAY. CITY SEWER MAIN IS IN THIS AREA. WATER FLOW COULD POSSIBLY CAUSE DAMAGE TO SEWER MAIN.

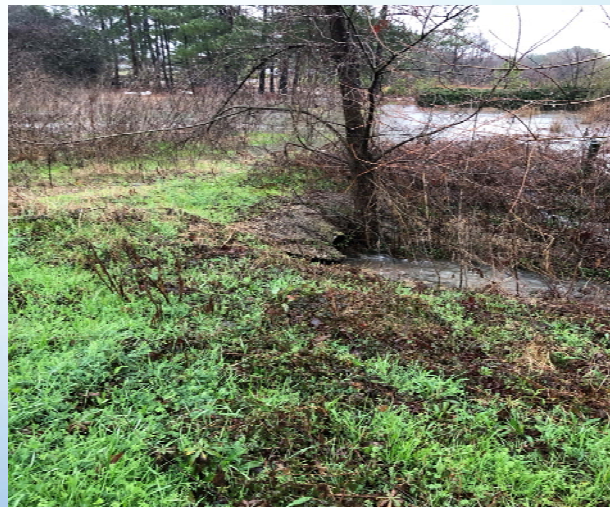
## PATTEN & LOOP 564

SOUTH SIDE OF OLD DRIVING RANGE DRIVEWAY. VERY LITTLE WATER COMING FROM DISCHARGE SIDE OF CULVERT DUE TO DEBRIS COGGING INLET SIDE.

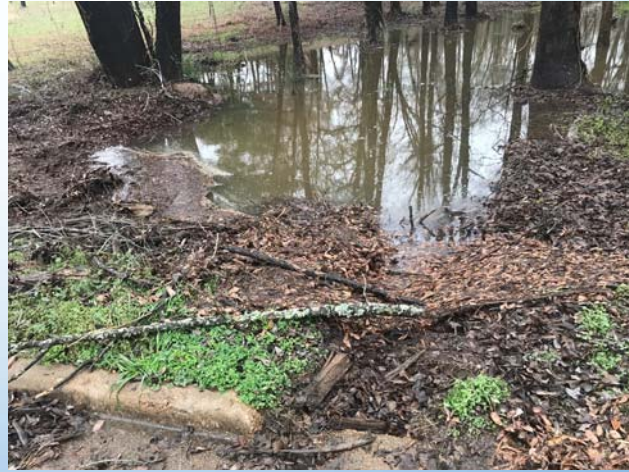
## PATTEN & LOOP 564

TAKEN AFTER WATER RECEDED. LOOKING ON MISD SIDE OF PATTEN. CULVERT IS CLOGGED WITH DEBRIS CAUSING WATER TO RUN OVER THE ROAD.

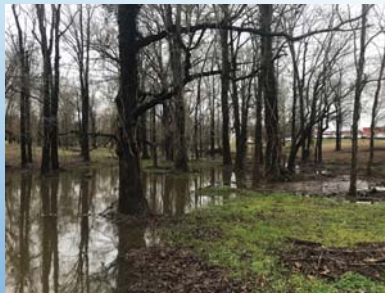
## PATTEN & LOOP 564

TAKEN AFTER WATER RECEDED. TAKEN FROM PATTEN STREET LOOKING ON MISD PROPERTY. THIS PROPERTY WAS CLEARED FOR SECURITY PURPOSES. THE SMALL DEBRIS WAS MULCHED AND FLOWS TO THE CULVERTS THUS CLOGGING THEM.

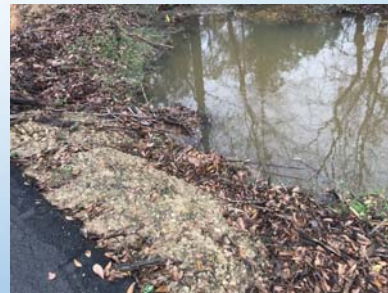
TAKEN AFTER WATER RECEDED. LOOKING ON MISD SIDE OF PATTEN STREET. DEBRIS FROM MISD PROPERTY CLOGGING SECOND CULVERT. THIRD WAS CLOGGED AS WELL.

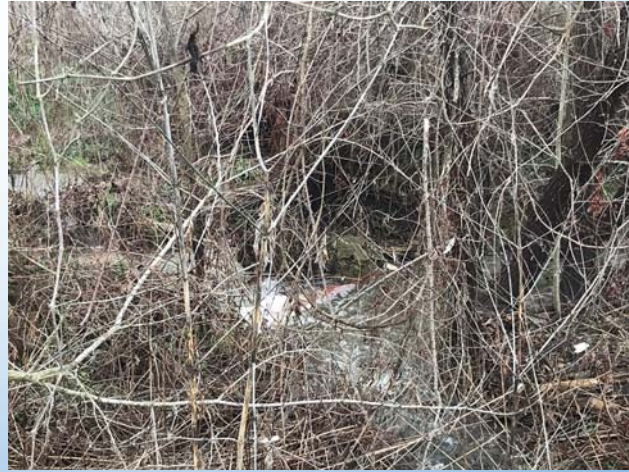
## PATTEN & LOOP 564

TAKEN AFTER WATER RECEDED. LOOKING ON THE SOUTH SIDE OF DRIVE WAY OF OLD DRIVING RANGE. WATER IS DIVERTED AROUND THE DRIVE WAY BECAUSE OF DEBRIS FROM MISD PROPERTY. THIS IS AN EXPOSED CITY SEWER MAIN CAUSED FROM WATER EROSION.

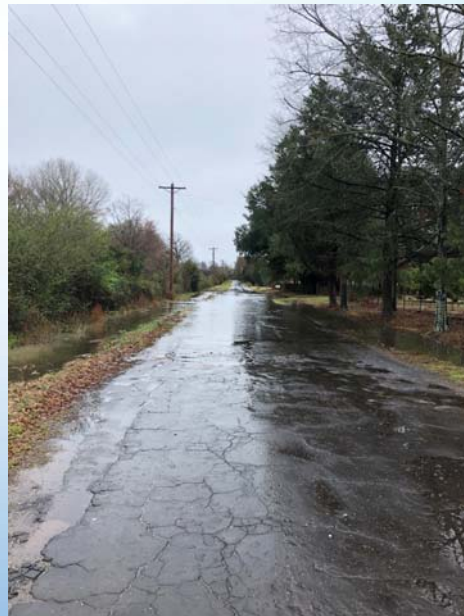
## BOUNDARY ST.

BOUNDARY STREET AND CR 2810. LOOKING EAST.

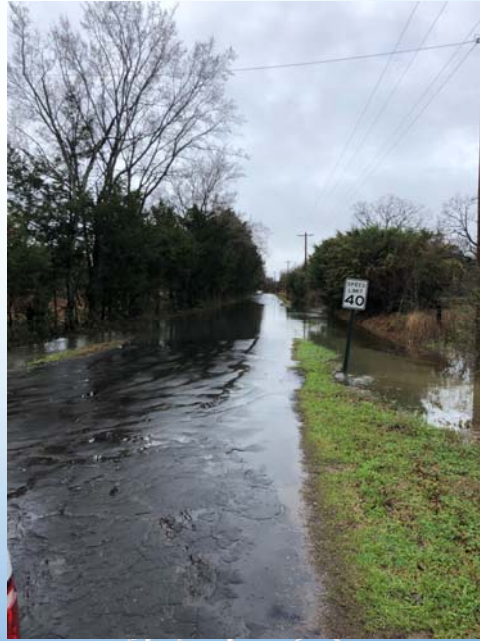
## BOUNDRY ST.

BOUNDARY STREET & CR 2810. LOOKING  
WEST ON COUNTY PORTION OF  
BOUNDARY/CR 2800.

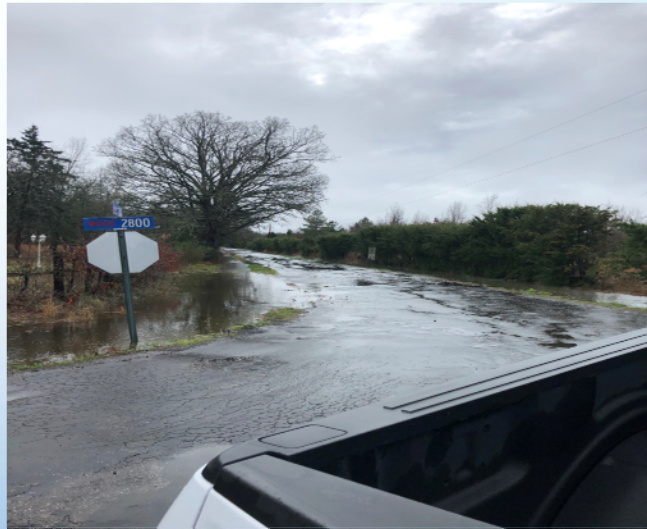
## BOUNDRY ST.

BOUNDARY STREET AND CR 2810. LOOKING  
SOUTH DOWN 2810.
